# Feasibility Study for Adaptive Use of The former D+H Freight Building 1410 Erie Boulevard, Schenectady, NY (a.k.a. Grossman's Bargain Outlet)

September 30, 2014

TAP, Inc.  
210 River Street  
Troy, NY 12180  
(518) 274-3050

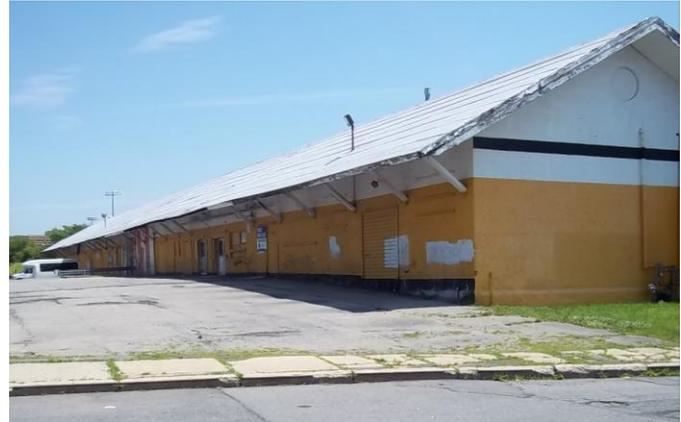
Front façade facing Erie Blvd. with parking lot in front.

On the original freight building, the main entry doors are aluminum and glass storefront doors. It is unknown if these were the original points of entry into the building. There are multiple loading bays on both the front and rear facades, some with overhead garage doors and some boarded up. Although the floor height and now-missing exterior loading docks were originally about 3.5' above grade, the grade of the front parking lot has been raised flush with the storefront entry. There are no windows in this section, nor are there any windows in the 1-story rear addition.

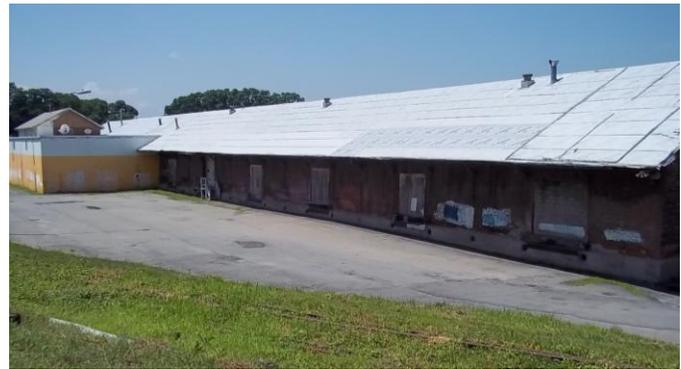
Rear façade, showing 1-story rear addition.

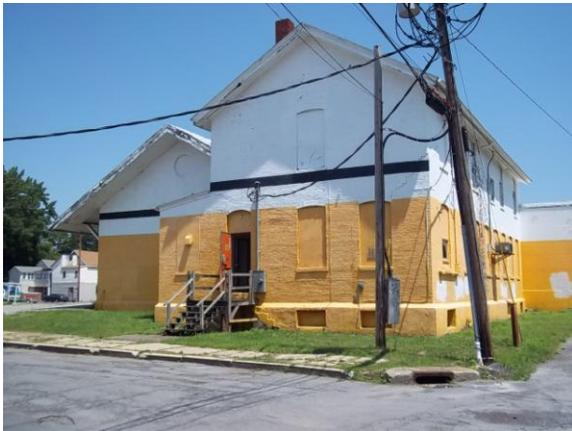
SW façade facing Jefferson St., w/2-story office

The 2-story freight office's only exterior door has been replaced with a steel door with infill panel above to fill the masonry opening. All of the original windows are missing and boarded up, except for a few smaller replacement windows on the second floor which do not fill the original opening.

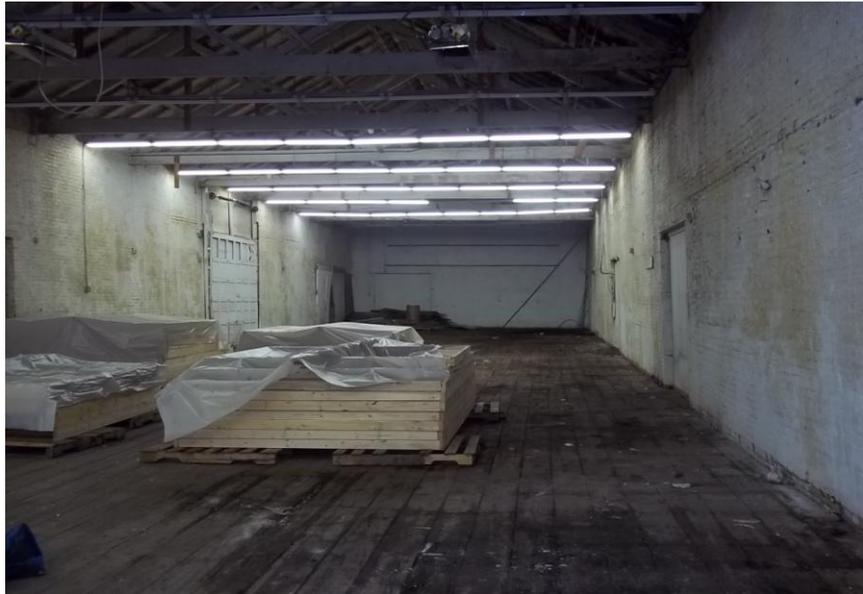
The original freight building has a clear-span wood roof truss, and no columns. Where the original rear brick bearing wall was removed to open up the freight building to the additions, a steel beam and steel columns were installed. The 1-story rear addition has steel roof framing. The basement and 1<sup>st</sup> floor of the 2-story freight office have wood beams and columns down the centerline which support the floor above, but the 2<sup>nd</sup> floor is wide open without columns, and a wood framed roof.

Original freight building interior.

The floor of the freight building is solid wood consisting of 3” thick members side by side, over a crawl space. The 1-story rear addition has a concrete slab floor. The 2-story addition has wood finished floors over wood joists on both stories. With the exception an office and toilet rooms, the space is wide open on all floors with few partitions and few finishes. There is no visible structural damage inside the building.

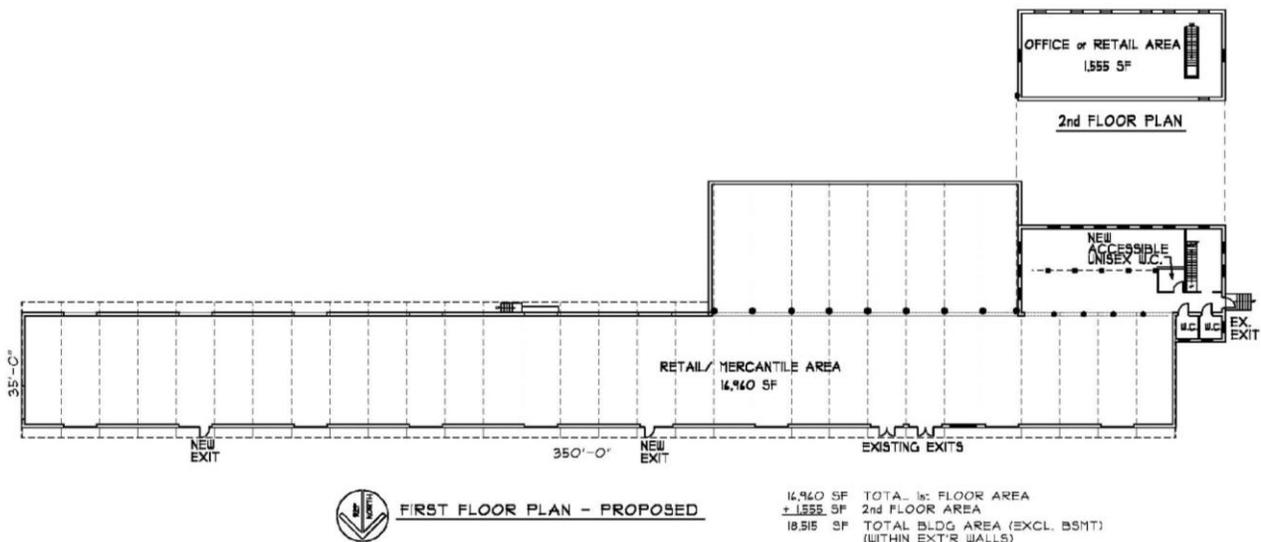
The owner envisions this building as a retail store, which is a continued use. The following code analysis and approval processes are based on the schematic layout below, showing one retail tenant occupying the entire building.

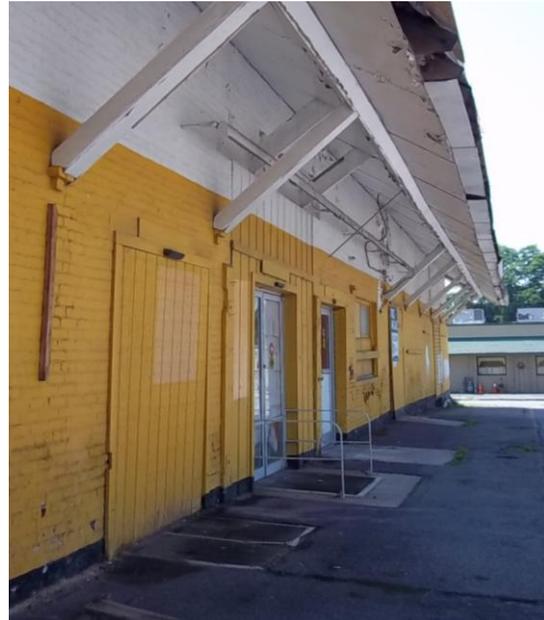
There are two accessible building entrances in front, consisting of double doors with automatic openers. The right side entrance has exterior stairs up to the doors at the 1<sup>st</sup> floor level.

Existing front entrance

**The Group M retail store requires full accessibility, including an accessible entrance, accessible route within, and accessible toilet room(s).**
