ITS
NUMBER 52

Interpreting The Secretary of the Interior's Standards for Rehabilitation

Subject: Incorporating Solar Panels in a Rehabilitation Project

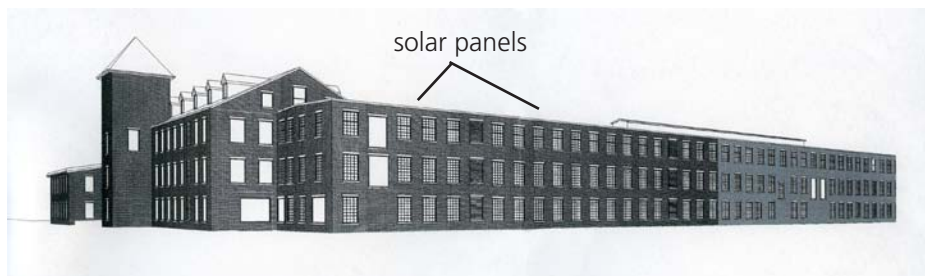
Because of the size of this historic mill, a large array of solar panels could be installed on the flat roof without being seen from the ground.

The rehabilitation of this mid-nineteenth century mill incorporated a large, roof-mounted photovoltaic installation. Although the historic building does not have a parapet wall at the roofline, the height of the building and the arrangement of the panels render the entire installation invisible from the ground. It is important to note that the panels are placed horizontally. Had the panels been installed with a vertical tilt, the angle required to maximize efficiency would have caused the panels to extend significantly higher above the roof. Simply changing the direction in which the panels are tilted can affect their visibility and reduce their impact on the character of the historic property.

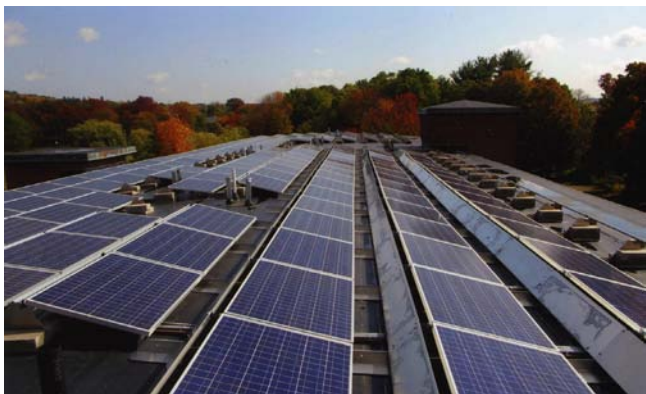
Solar panels installed on the flat roof.

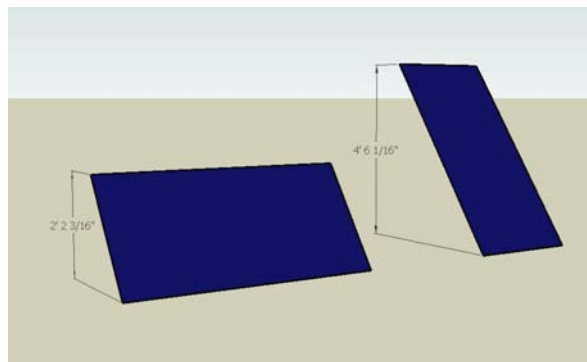
By placing the panels horizontally, the overall height of the installation and its visibility is reduced.

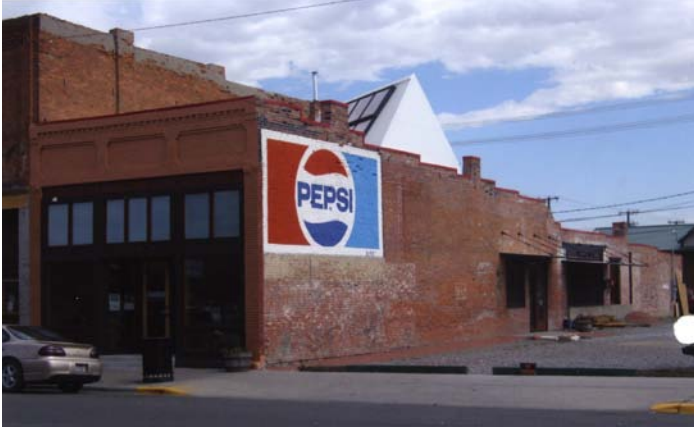
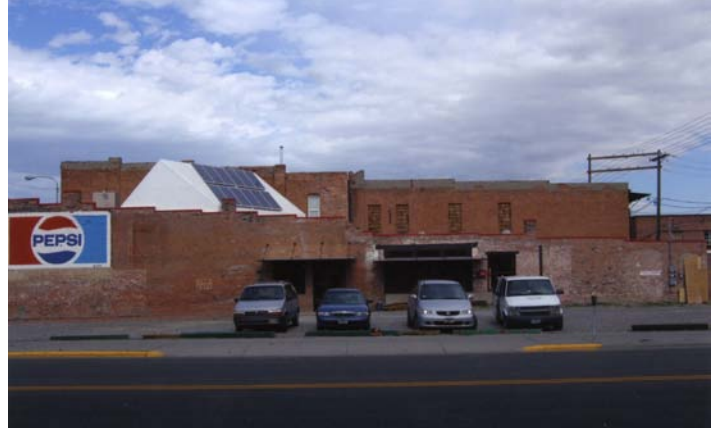
The addition of a large rooftop monitor featuring skylights on the front slope and solar panels on the rear slope is not compatible with the historic character of this small, one-story commercial building.

Application 2 (*Incompatible treatment*): During the rehabilitation of this late-nineteenth century commercial building, a conspicuous rooftop monitor with prominent solar panels and skylights was constructed on the one-story structure. The size and finish of this rooftop addition are incompatible with the historic character of the building. However, the building could have accommodated both skylights and solar panels if they had been installed differently. An alternative design that could have met the Standards would have included low-profile skylights and solar panels concealed behind the parapet wall.

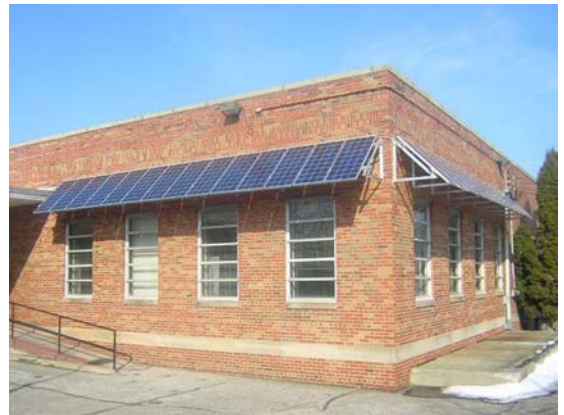
Above: Shown from the rear of the property, these solar panels serve a secondary function as awnings to shade south-facing windows. Because of their location at the back of the building immediately adjacent to a loading dock, the installation of these panels does not affect the historic character of the property.

Application 3 (*Compatible treatment*): The rehabilitation of this historic post office incorporated solar panels as dual-function features: generation of electricity and shading for south-facing windows. In this instance, the southern elevation of the building is also a secondary elevation with limited visibility from the public right of way. Additionally, because this area of the building is immediately next to the post office’s loading dock, it has a more utilitarian character than the primary facades and, therefore, can better accommodate solar panels. Because the panels are in a suitable location at the rear of the property and are appropriately sized to serve as awnings, they do not affect the overall historic character of the property. Additionally, a screen of tall plantings shields the solar panels from view from the front of the building, further limiting their visibility.

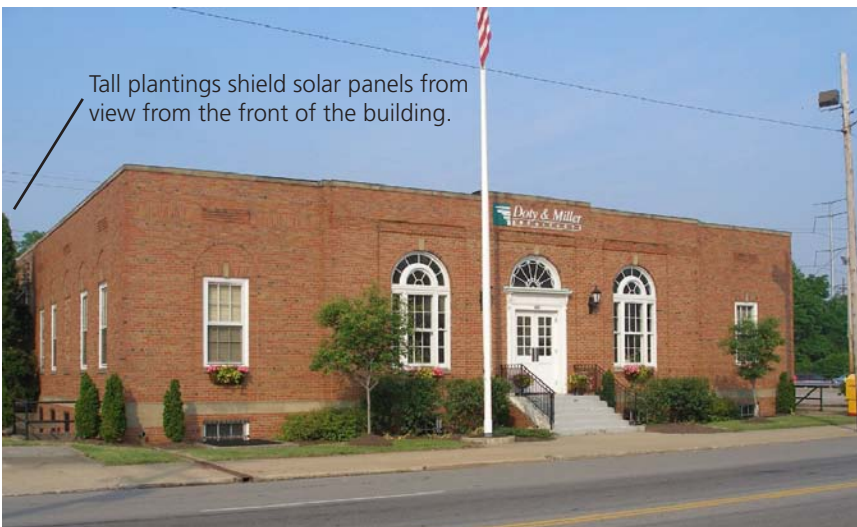
Tall plantings shield solar panels from view from the front of the building.

Left: The solar panels are not visible from the front of the building. Additionally, even if the vegetation were removed, the installation would only be minimally visible along an alley at the rear of a secondary side elevation.
